John Deere Horicon Works

HOOD HINGE POST BREAKS

LX172, LX176, LX178, LX186 and LX188 Lawn Tractors
GT242, GT262 and GT275 Lawn and Garden Tractors

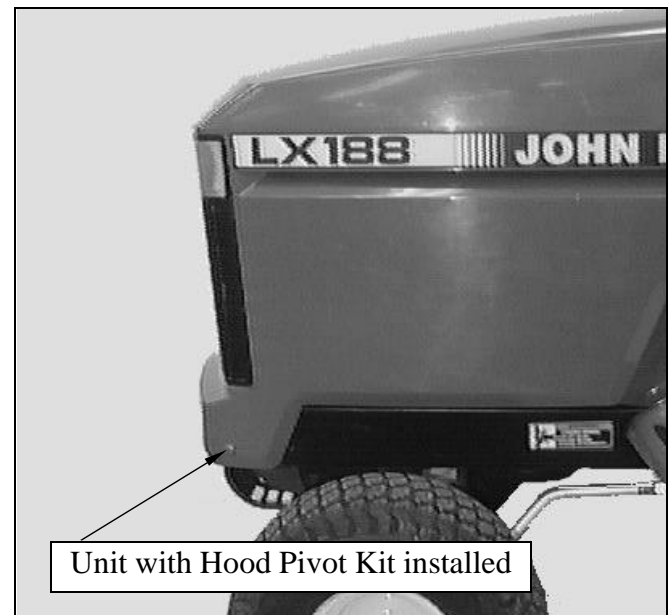
- Hood hinge post breaks on impact.
- Cannot repair hinge without replacing hood.
- Hood cost a factor, especially on tractors out of warranty.

For low cost repair, order and install Hood Pivot Kit (AM122166).

Kit consists of two truss head bolts, lock nuts, bushings, friction pads, and installation instructions. Installation involves drilling (2) 1/4-in. diameter holes.
